# Failure Type Analysis, Mitigation, and Recommendation Using Slope Stability Radar at PT.Kuansing Inti Makmur to Enhance Sustainable Mining

Muhammad Naufal Alfaiz<sup>1</sup>, Dimas Ihsan Bagaskoro<sup>2</sup>, and Muhammad Yadi<sup>3</sup>

<sup>1</sup> PT Golden Great Energy Mines

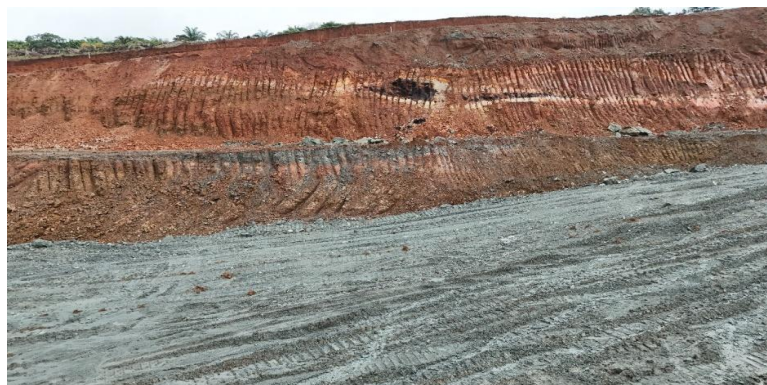
A stable slope with no potential for landslides is characterized by a combination of favorable geotechnical and hydrological conditions. These include an adequate factor of safety (typically above 1.3 for static conditions), well-compacted and cohesive materials, proper drainage to prevent water infiltration, and gentle slope angles within the recommended design limits based on the rock or soil type. Vegetation cover can also contribute to slope stability by reinforcing surface materials and reducing erosion. Additionally, the absence of geological discontinuities, such as faults, joints, or weak bedding planes, further minimizes the risk of failure. Regular monitoring and maintenance, along with adherence to engineering design standards, help ensure the slope remains stable under both natural and operational conditions.

**Figure 3.1.** Normal bench with no potential slope failure.

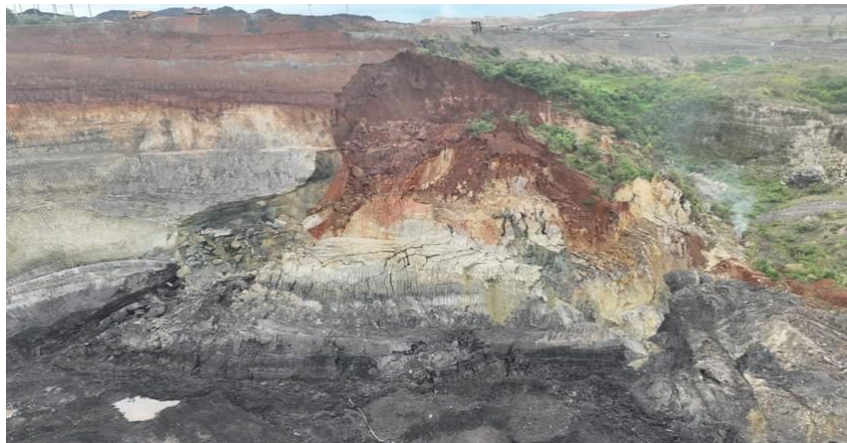
Creep is a slow and continuous movement of soil or rock downslope over time. Visually, this type of failure is identified by subtle surface indicators such as tilted trees or poles, cracks near the crest, distorted drainage lines, and bulging at the toe of the slope. Creep is commonly triggered by natural factors like seasonal moisture changes, wet-dry cycles, or minor seismic vibrations. In mining operations, it may also be caused by repetitive equipment loading or poor drainage, which gradually weaken slope materials. . Though creep is a slow process, its accumulation can signal the potential for more rapid and dangerous slope failures if not monitored and addressed properly.

**Figure 3.2.** Creep landslide.

Mitigation of creep-related deformation focuses on long-term slope management. Recommended actions include:

- Slope regrading to reduce overall inclination and minimize shear stress,
- Surface and subsurface drainage control to prevent water accumulation and reduce pore pressure,
- Installation of geosynthetics or retaining structures to improve slope resistance,
- Erosion control and vegetative cover to protect surface layers.

Operational adjustments, such as limiting heavy equipment traffic near affected areas, are also necessary. All decisions should be based on geotechnical risk assessment supported by real-time monitoring.

Safety Protocols for Creep Failure:

- Minimum Safe Distance (Barricade) : 1.5 times the height of the affected slope, measured from the crest.
- Safe Re-entry Time After Initial Movement: 2 hours after slope failure and SSR reading had linear phase deformation
- Inspection Interval: Every 30 minutes.

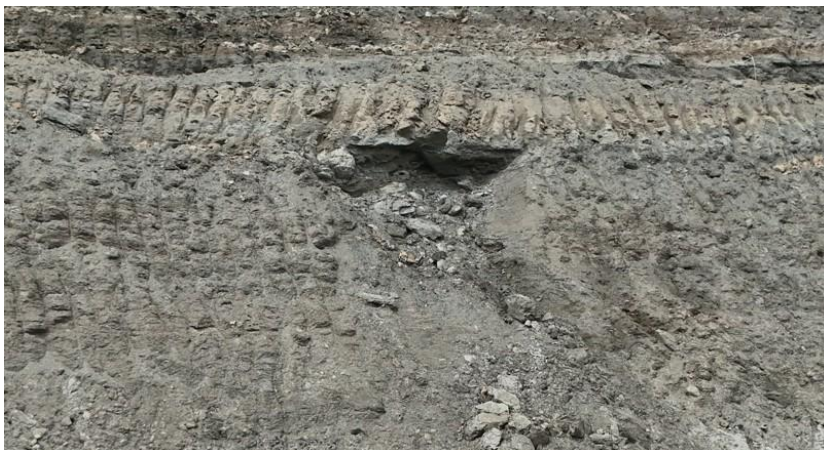
Rockfall is the sudden detachment and free fall of rock fragments or blocks from steep or vertical slopes. It is visually identified by fresh scarp surfaces, accumulated debris at the slope toe, and open joints or tension cracks near the crest. Affected slopes often exhibit scattered boulders, exposed fractures, and areas of loose, unstable rock with sharp edges and uneven textures. Natural triggers include weathering, rain infiltration, and freeze-thaw cycles, while operational causes may involve blasting vibrations or undercutting during excavation. Rockfalls typically occur without warning and pose serious safety risks, particularly in highwall areas and active pit faces. Although some events are minor, frequent or large-scale rockfalls can significantly compromise slope stability and operational safety.

**Figure 3.4.** Rockfall.

Rockfall mitigation emphasizes structural stabilization and hazard containment. Recommended measures include:

- Geotechnical mapping and structural analysis to identify unstable blocks (Kinematic analysis),
- Installation of rock bolts, wire mesh, or shotcrete to stabilize potential failure zones,
- Construction of catchment systems, such as rockfall ditches and protective berms,

- Implementation of exclusion zones and controlled access near active highwalls.

Routine scaling operations are advised, especially following rainfall or blasting, to remove unstable rock fragments before failure occurs.

Safety Protocols for Rockfall:

- Minimum Safe Distance: 40 meters from the base of exposed slopes
- Safe Re-entry Time After Rock Detachment: 30 minutes and SSR reading had linear deformation
- Inspection Interval: Every 1 hour
